SKYlines

A SKYLINE RESTORATION PUBLICATION

The Effects of “Frost Jacking” on Building Façades

Below-Grade Waterproofing: Gravity Feed and Pressure Injection Applications

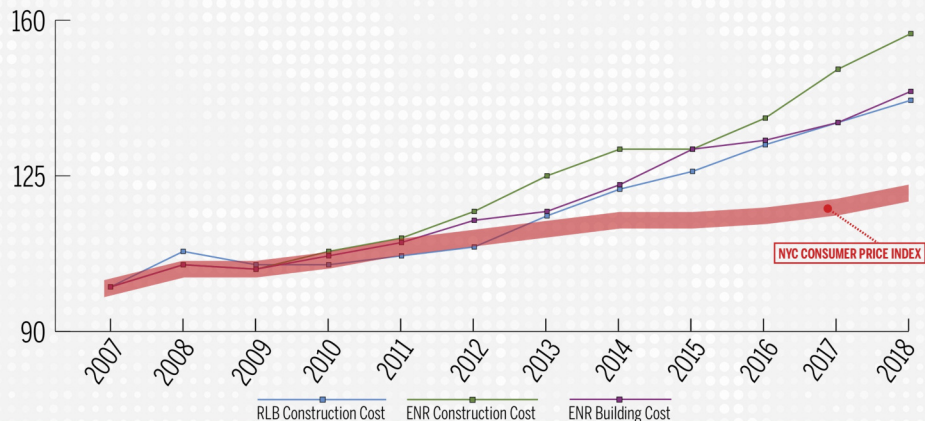
NEW YORK CITY CONSTRUCTION COST INDICES, 2007-2018
BASE YEAR: 2007, INDEX 100

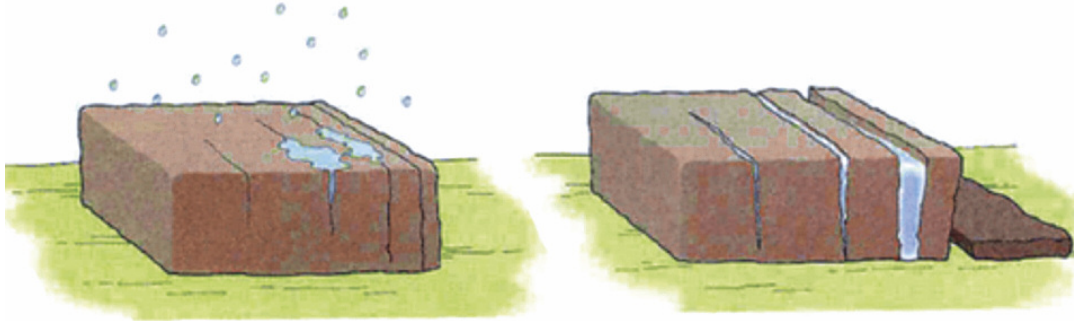
Cycles of precipitation at temperatures above freezing followed by temperatures below freezing expand the sizes of cracks, in a phenomenon known as “frost jacking,” eventually causing visible distress. GRAPHICS: SUPERSTRUCTURES ENGINEERS + ARCHITECTS

In New York City, every time it rains or snows, water seeps into crevices, pores, and even micro-cracks in building façades and parapets, whether in concrete, brick and mortar, or other architectural materials. Unlike other liquids, water expands in size after it freezes. Cycles of precipitation at temperatures above freezing followed by temperatures below freezing expand the sizes of cracks, in a phenomenon known as “frost jacking,” eventually causing visible distress. This distress needs to be investigated to ensure that hazardous conditions haven’t occurred. As buildings age, these cracks can also become the source of water damage and even leaks into the interior of the building.

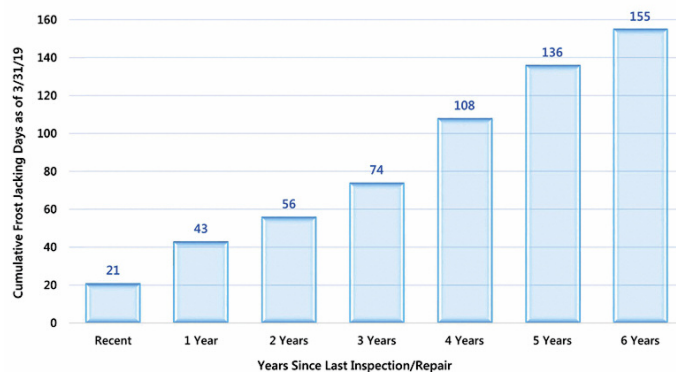
SUPERSTRUCTURES’ Frost Jacking Day Tracker shows that as of March 31st 2019 there had been 155 such days in the past 6 years. (superstructures.com)

What is important with respect to potential damage to the building envelope is the accumulation of those days over time. **SUPERSTRUCTURES’ website** includes a **Frost Jacking Day Tracker**,

which shows this accumulation – as of March 31st 2019 there had been 155 in the past 6 years.

We’re using data provided to the **National Weather Service** by the weather station in Central Park. Since minimum and maximum temperatures are recorded at midnight, we look for days where the minimum temperature is 30 degrees F or lower preceded by days where the maximum temperature is 33 degrees F or higher, with rain and/or snow one or two days before.

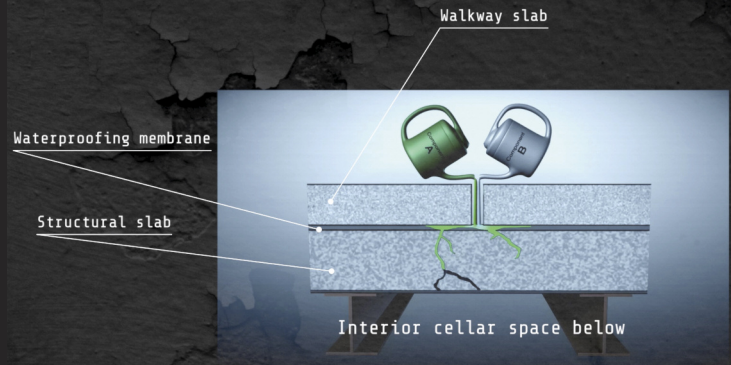
CGI's gravity feed waterproofing application incorporates feeding the 2 water-like viscosity liquid components within the cleaned out expansion joints to create a gel barrier, followed by the application of new urethane caulking.

CGI's **gravity feed waterproofing application** incorporates feeding the 2 water-like viscosity liquid components within the cleaned out expansion joints to create a gel barrier, followed by the application of new urethane caulking.

Typically, a vaulted sidewalk structure is comprised of a horizontal structural slab with a top-side waterproofing membrane and a walkway slab on top of the structural slab. The structure typically has expansion joints installed every 20 ft. or 4 flags apart, which are prone to deterioration as a result of freeze-thaw cycles and pedestrian traffic, giving way to rainwater to enter from the compromised membrane locations on top of the structural slab.

CGI's gravity feed waterproofing application begins with mechanics removing the deteriorated old caulking and debris from within these joints, allowing for two liquid components to be gravity fed at a longer setting time. As a result of the two components' water like viscosity, the combined solution chases through the opened joints like rainwater, allowing the resulting gel to form a band where the membrane was compromised. Subsequently, backer rod is inserted within the joints followed by caulking with the appropriate

urethane sealant. In the case of a granite slab, where the top sidewalk expansion joint runs to the cellar underside of the granite, CGI's mechanics insert oakum within the joint to act as a form, which then allows the gravity feeding waterproofing method to take action utilizing new urethane caulking.
